Site Inspection, Company, MCW Enterprises, Gold Queen Mine, S/017/035, Garfield

County, Utah

Gold Queen Mine S017/035

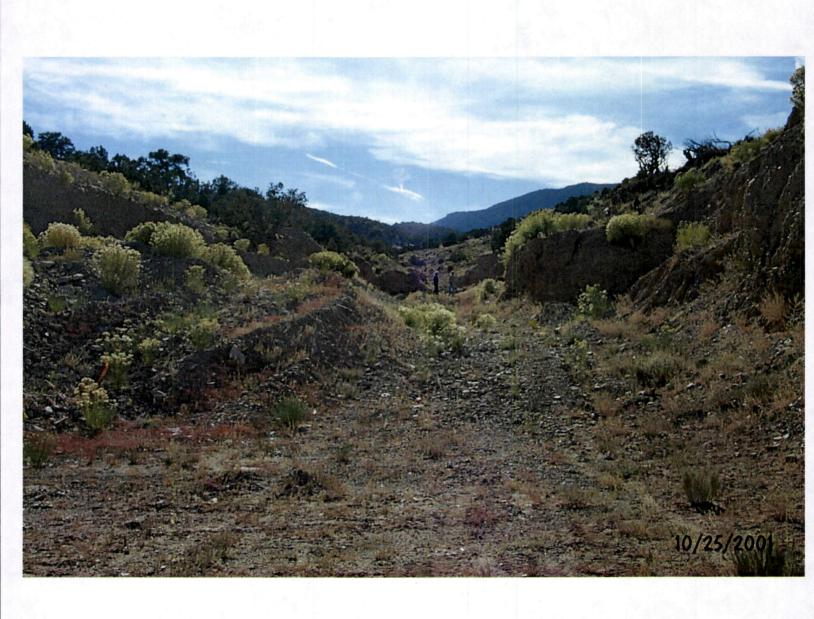
ONLY ONE PHOTO PATIEN LOOMING SW, THE OTHER PHOTOS DID NOT COME OUT.

A lot of the site is revegetating with rabbit brush and what looks like willows being in the bottom of the drainage. We could probably give credit for at least 20-30 percent of the site being reclaimed on it's own. The remainder requires the removal of some pond embankments and some general recontouring and reshaping of the channel.
